Damage Assessment and Guidelines for Restoration Methods of Ancient Brick Structures at Sambor Prei Kuk, Cambodia

Ichita Shimoda, Sokuntheary So & Vitharong Chan

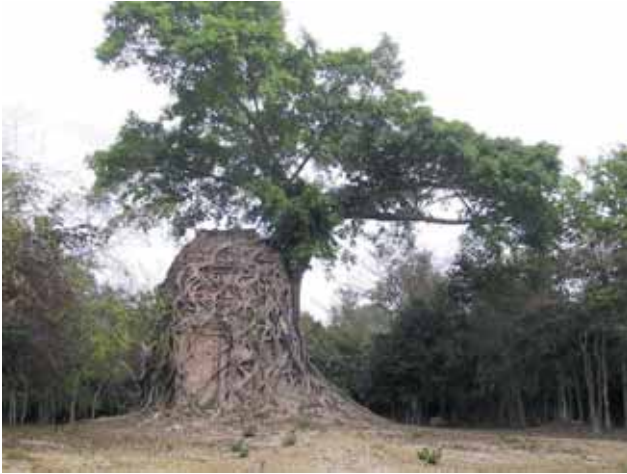
Figure 2. One of the brick structures with growth of tree (N18 shrine, Prasat Chrey, M.17).

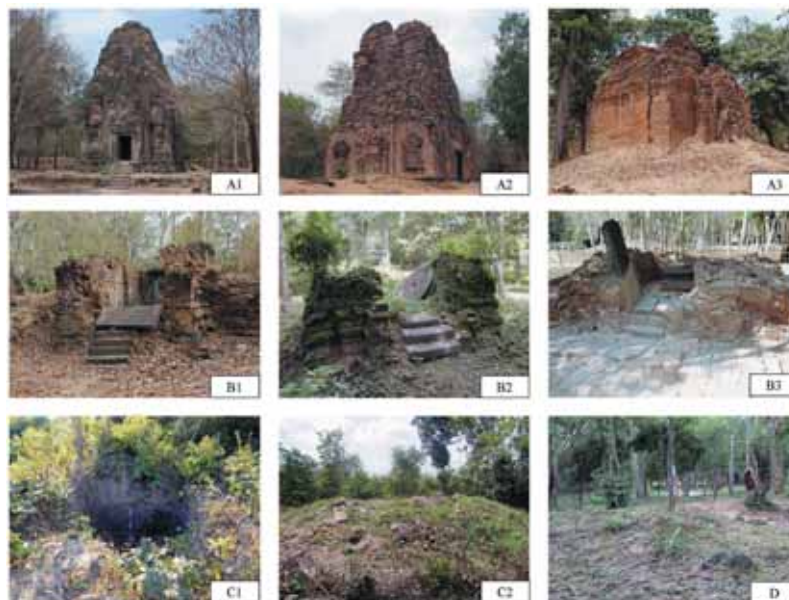
Figure 5. Classification of the state of preservation (A1: S1 shrine in Prasat Yeai Poeun (M.24), A2: N15 shrine in Prasat Sambor (M.20), A3: N13 shrine in Prasat Sambor (M.20), B1: S6 gate in Prasat Yeai Poeun (M.24), B2: S17-1 shrine in Prasat Yeai Poeun (M.24), B3: N14-2 shrine in Prasat Sambor (M.20), C1: brick structure at M66-1, C2: brick structure at M68, D: C19-1 brick structure in Prasat Tao (M.26)).

There are 34 structures that have been preserved to the element of the roof (A1, A2, A3). Thirty-two are located in the Temple Zone, and only two are located in the Moated City Zone. There are 39 structures that have been preserved to the element of the wall (B1, B2, B3). It is possible with these structures to identify the original plan. Other structures are completely destroyed and it is difficult to estimate the original shape of structure (C1, C2, D). Within them, 47 structures partially retained the interior wall or the wall of underfloor space (C1), and 157 structures completely lost the original brickwork and are now brick mounds (C2). Among these mounds, some of them have been left with a quantity of brick material, but some have been left with only a small number of bricks. Ten sites consist of only the concentration of fallen bricks or laterite material which were elements of the foundation structure on the flattened raised ground (D). In addition, it is anticipated that other brick structures must be buried because previous archaeological excavation surveys unearthed many structures even though there were no traces of structure and scattering materials on the ground.

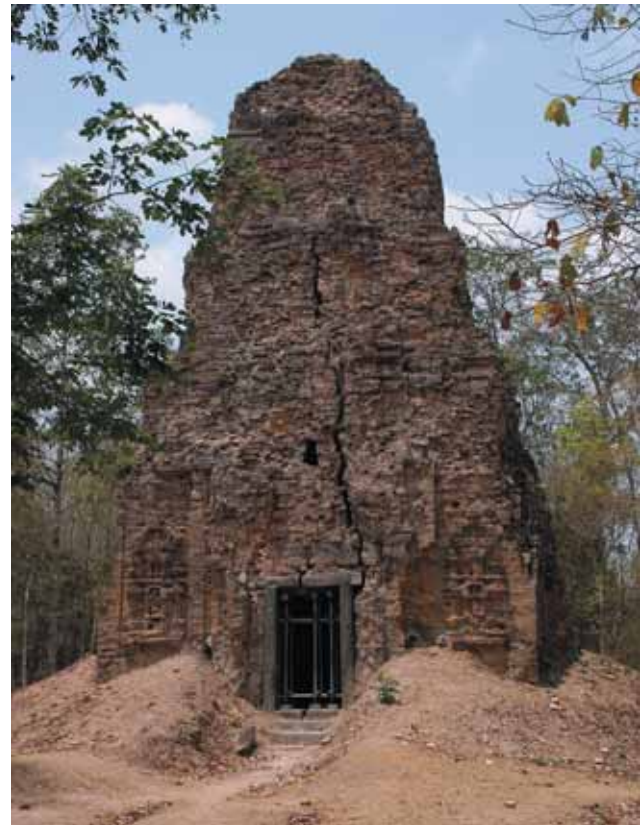
A) collapse around the door opening and vertical crack above the door opening (Figure 6);

Figure 6. Collapse around and above door opening (N11 shrine in Prasat Sambor, M.20).

However, the openings were still one of the critical structural weakness, and extensive failures are observed at most structures. Looting of the decorative lintel above the door might also be one of the causes of collapse around the door opening. Unfortunately, most of the decorative lintel has been lost by past looting. The decorative lintel was supported by an element of projected decorative brickwork pediment above the door opening.

The partial collapse of the pediment by the looting of the decorative lintel led to the chain of collapse around the door opening. The instability around the door openings is still a significant cause of further failure today.

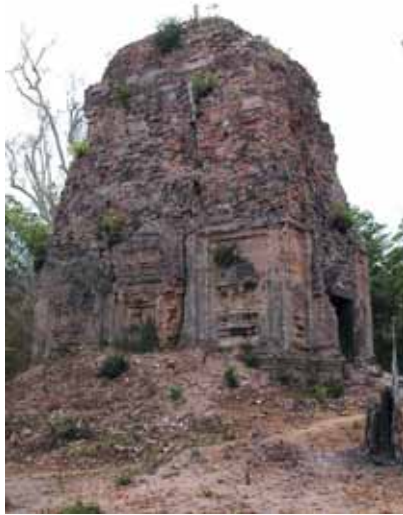
B) vertical crack of wall at the middle of the wall (Figure 7) and corner of the wall (Figure 8);

Figure 7. Vertical crack at the middle of wall (N21 shrine in Prasat Sandan, M.10).

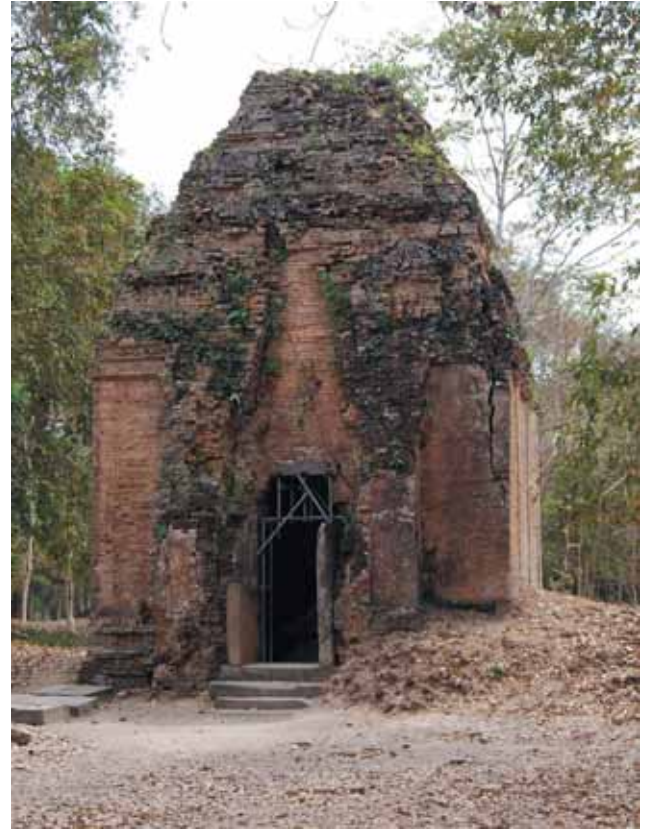
C) deformation, crack, and missing corner of the wall (Figure 9);

Figure 9. Crack at the corner of wall (N10 shrine in Prasat Sambor, M.20).

Cracks and detachment due to partial deformation is observed at the corner of walls and projected decorative elements. Partial dismantling and reassembling of these deformed brickworks is the effective method for recovering the stability. This method is widely accepted in the brick restoration in Angkor monuments such as Phnom Bakheng and Preah Ko (Fajcsak and Renner 1996; Phet 1999). Installing stainless-steel pins for connecting the deformed elements and main body of the structure and adding the stainless-steel plates at the location of load concentration are also effective ways for long-term stabilization.

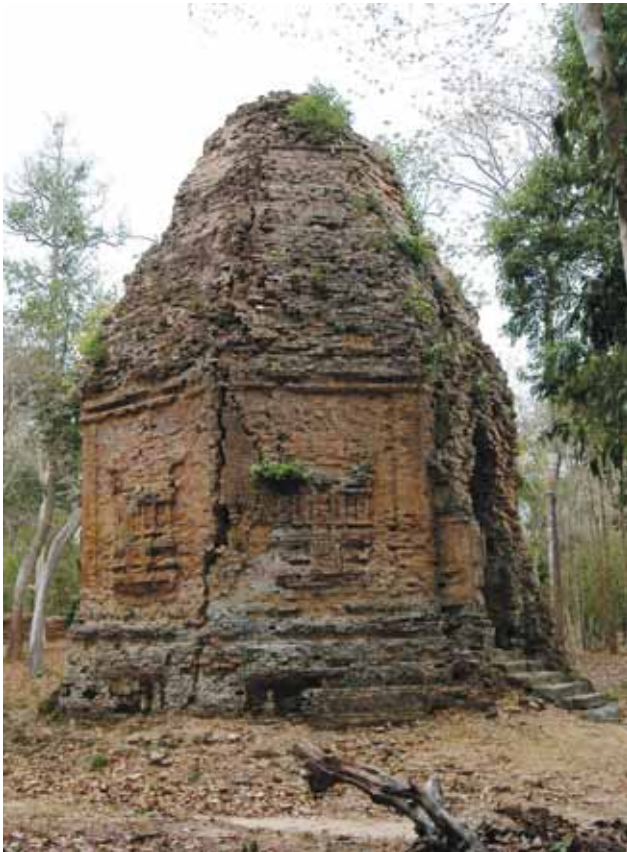
Figure 8. Vertical crack at the corner of wall (S7 shrine in Prasat Yeai Poeun, M.24).

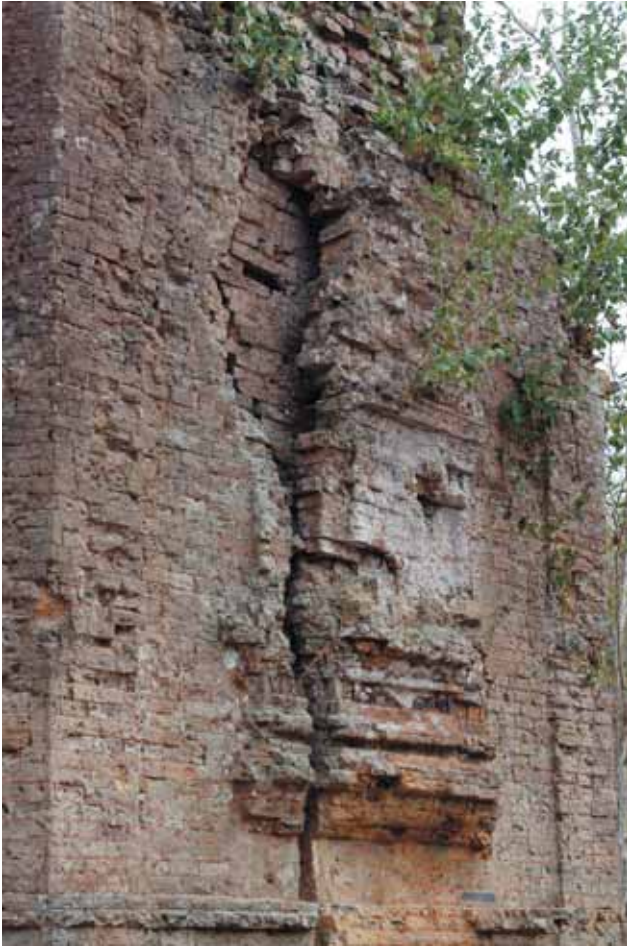
D) detachment and missing projected decorative element (Flying Palace, pediment, pilaster) (Figure 10); and

Figure 10. Detachment of the projected decorative element, Flying Palace (S8 shrine in Prasat Yeai Poeun, M.24).

Plant invasion is also the significant cause of the damage at the projected decorative element such as Flying Palace and pediment. The upper surface of the projected decorative element is a good place for the plant settlements and their roots detach the projective brickwork. Fragmented brickwork reduced the stability and risk of the collapse by heavy rain and strong winds are increased.

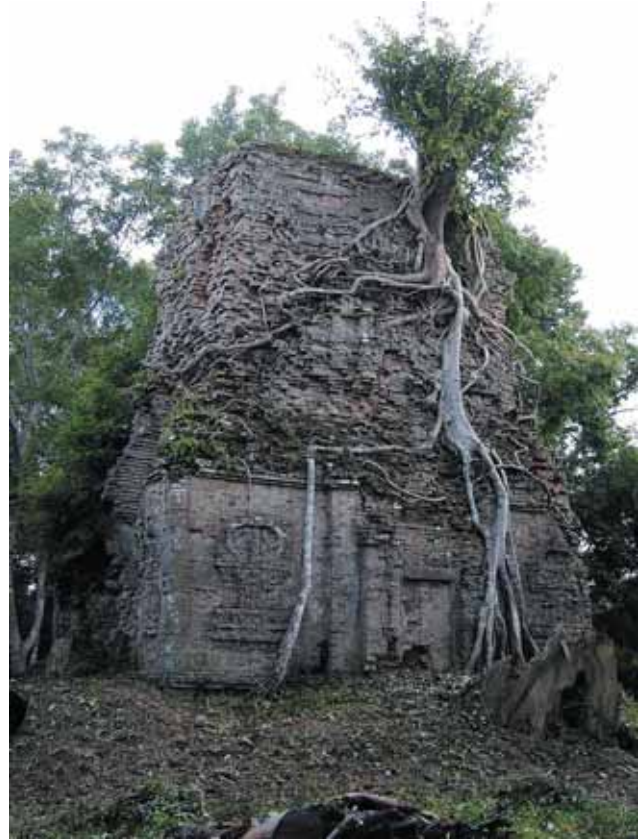
Figure 11. Loose and fragmentation of brickwork of roof part (W shrine in Prasat Kouktroung, M.41).

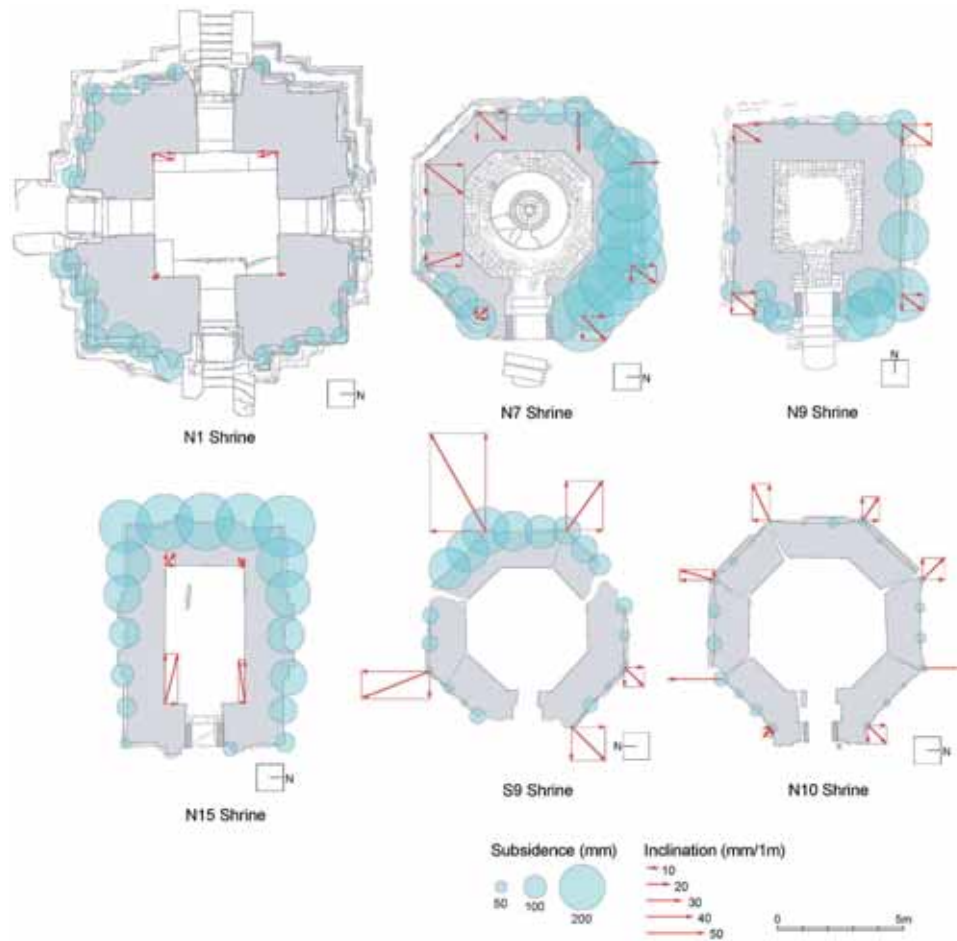
the most deeply submerged at 304 mm. The sloping ratio is calculated at approximately 3% (submerged value 304 mm/width of structure 9.8 m). Each wall is also inclined to the northeast direction in conjunction with the uneven subsidence. The horizontal dimension at the largest corner is about 35 mm per meter. It means that the inclination ratio is 3.5%. Thus, the ratio of the subsidence and inclination are almost the same value at the N7 shrine. There are several small vertical cracks at the wall of this shrine. It is unlikely that these cracks were caused by uneven settlement because of the above result. Since the crack is closed at the upper part, it is predicted that these cracks have been caused by the outward deformation of the base.

N15, N9, and S9 shrines also measured largest value of uneven subsidence after N7 shrine. At two of them, S15 and N9 shrines, every wall is inclined to the same direction in conjunction with the subsidence. These structures have no vertical cracks because these structures were tilted in accordance with the subsidence.

On the other hand, at the S9 shrine, all walls are inclined outward whereas the foundation was subsided in one direction. The southwest corner which has the largest subsidence shows the largest inclination (86 mm/m), but the northeast corner which has the smallest subsidence also shows the outward inclination (42 mm/m). One of the octagonal structures S10 shrine has no observable large subsidence. However, each wall of this structure is inclined outward.

Figure 13. Uneven subsidence and inclination of brick structures: N1, N7, N9, N15, S9, and S10 shrines.

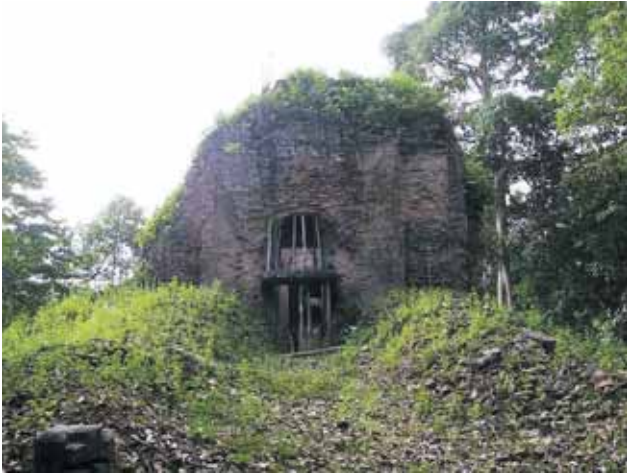
Figure 14. North elevation of the Central Shrine in Prasat Sambor, before restoration.

In the 20th century, the above fifth approach of installation of reinforcement structure with dismantling and reconstruction was often adopted in the Angkor monuments. The restoration project of Prasat Kravan, brick temples of the 10th century, was the representative work of this method. Five brick shrines and the platform were almost fully dismantled, and an RC structure was installed inside the foundation and walls. The original brick material, along with new brick, were assembled on the surface of this reinforcement structure. This method was approved at the time because the most important value of this temple was thought to be the bas-reliefs on the interior wall. However, it is now difficult to adopt this method today because our understanding of the authenticity was largely revised from the past through the long discussions (Athens Charter 1931; Charter of Venice 1964; ICOMOS Charter 2003). In addition, the restoration method and policy were also developed in Cambodia after the Angkor monument was inscribed on the UNESCO World Heritage List (Angkor Charter 2012). Therefore, the other four approaches that are acceptable options today were carefully discussed and the current restoration work of the Central Shrine of Prasat Sambor was applied (Figures 14–16).

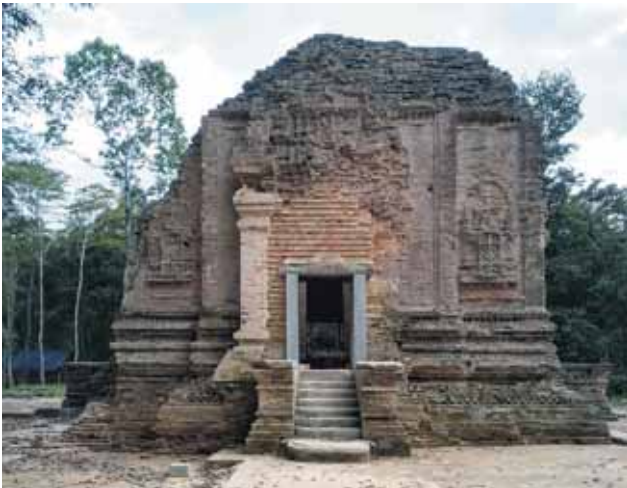
Figure 15. North elevation of the Central Shrine in Prasat Sambor, after restoration.

During the current restoration work of N1 shrine, fragmented brickworks on the upper layers of the remaining wall, corners of wall, and platform were partially dismantled and reassembled them for preventing further failures (Figures 15 and 16).

To prevent the settlement of vegetation on the upper surface of the brick remains, adding a few layers of new brick is an effective acceptable method. In this case brick should be carefully placed in order to drain the rain-water smoothly. High duration and strength mortar is recommended to use for this brickwork. Newly added brick layers shall be distinguished from the original bricks and limited to a minimum volume. These kinds of capping brick layers were added on the reconstructed parts on the top of the wall or roof during the current restoration work of the N1 shrine (Figures 15 and 16).

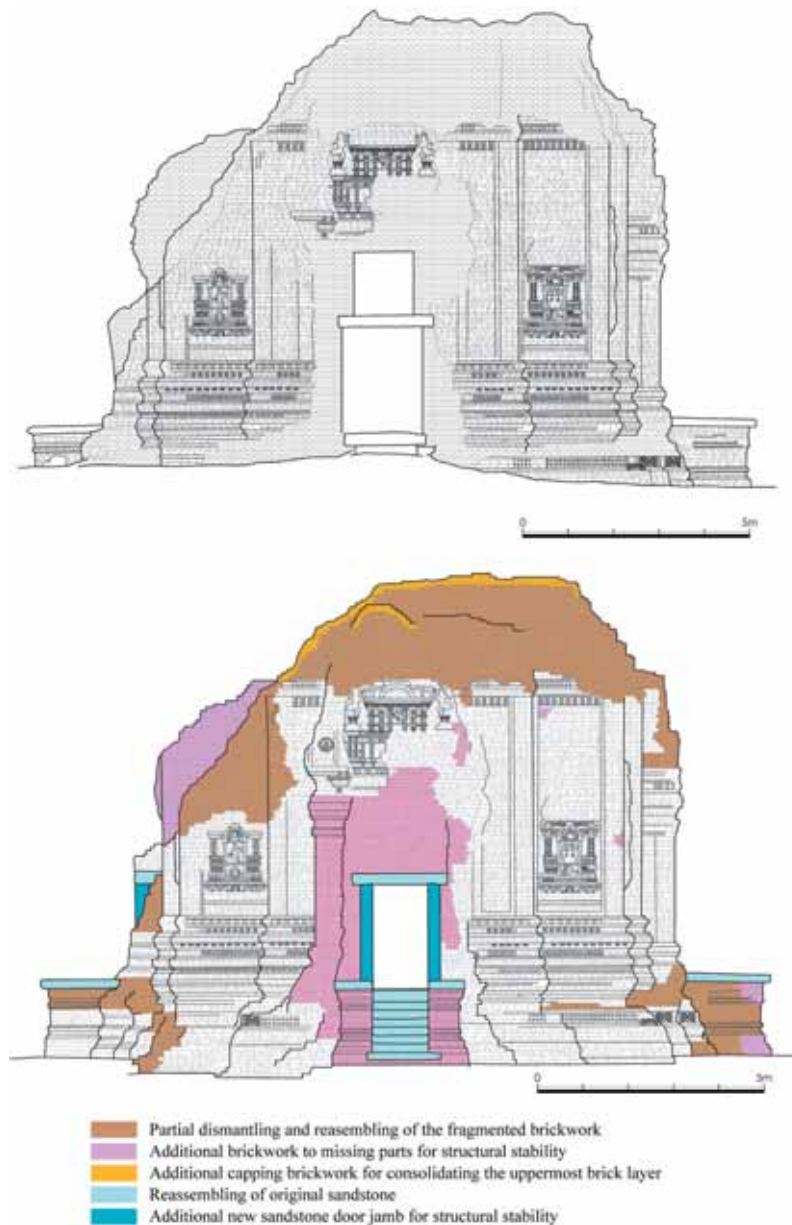
Figure 16. North elevation of the Central Shrine in Prasat Sambor (above: before restoration, below: after restoration).
