Observations of Microstructure Changes in Used Turbine Blade by IP-XRD SEM and TEM

Keizo Hashimoto, Hiroaki Fujita and Hiroshi Hamamoto

Department of Aerospace Engineering Teikyo University
1-1 Toyosatodai Utsunomiya 320-8551 JAPAN

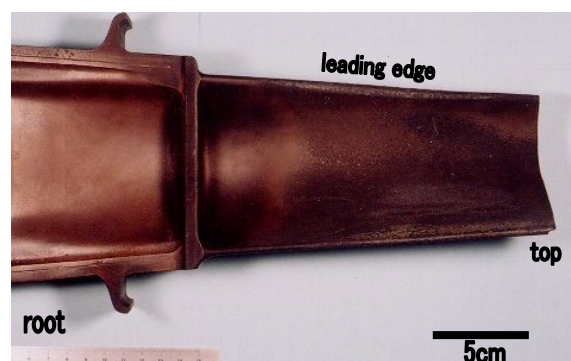
Fig. 1 First stage turbine blade

for 30,000 hours in an actual power plant. Since gas turbine was not the newest generation type, it was made from cast Ni base polycrystalline superalloy. Cooling holes whose diameter was 3mm were penetrated through from the root part to the top of the blade. Figure 1 shows a photograph of the used turbine blade. Center position of leading edge shows surface damage. Table 1 lists the alloy compositions of Ni based superalloy.

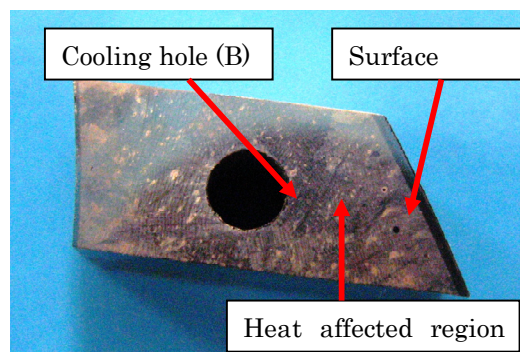
Although X-ray diffraction technique is a nondestructive method, a small block cut from the first stage turbine blade was examined, because of limitation of specimen stage in the X-ray instrument. Figure 3 shows the cross section of the block. Surface coating layer whose thickness was 2mm was observed.

Fig. 3 Cross-section of specimen

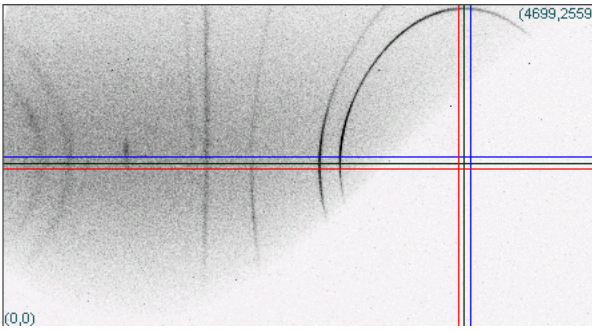
At the root position of the turbine blade, the effect of heat was reduced comparing with other positions of the blade, since it was cooled by air flow and attached to the turbine disc, during operation. Figure 4a demonstrates the two dimensional (2D) diffraction image from the root position of the blade. Continuous Debye-Scherrer ring pattern was observed. From the beam center, the first inner ring is indicating diffraction of Ni (111) planes, the second inner ring is Ni(200) planes, the third inner ring is Ni(220) planes, respectively. This diffraction image is elucidating that this observed area (0.3mm diameter) is consisting of randomly oriented fine polycrystalline aggregates. Intensity distribution of Ni(200) plane along ring is slightly heterogeneous due to the texture.

Fig. 4a IPXRD image from root position of cooled blade

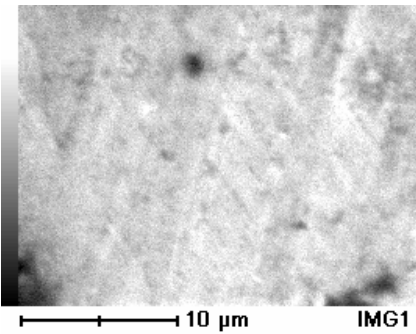
Fig. 4b SEM image of root position of cooled blade

Fig.4a. Average grain size was $30\ \mu\text{m}$ and γ' precipitate size was $0.5\ \mu\text{m}$, respectively.

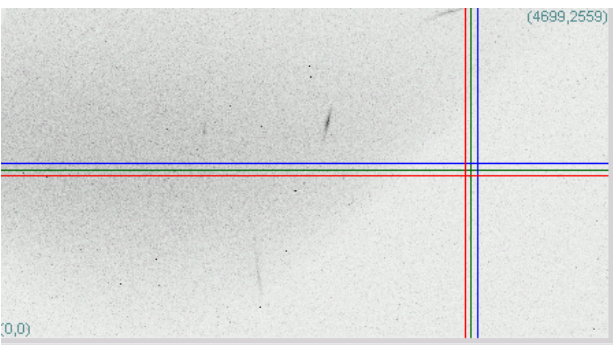
Figure 5a shows the 2D diffraction image at the vicinity of the cooling hole in the block as seen in Fig.3 (B). No ring pattern was observed. Diffused spot image was recorded at the 2θ angle of γ' (111) plane. It is suggesting that γ' precipitates are almost aligned toward the same direction but their size is very small. Figure 5b shows the SEM image of the same position of Fig.5a. Clearly, cuboidal γ' precipitates having almost the same crystal orientation are observed. Since average grain size of this position was 0.3mm , diffraction spot from γ phase seems to be hardly detectable. Analysis of the diffraction pattern in the reciprocal lattice space coincides with the SEM observations in the real space, each other. Other diffraction such as γ' (200) and γ' (220) planes are so weak that they are invisible.

Fig. 5a IPXRD image at the vicinity of cooling whole (region B)

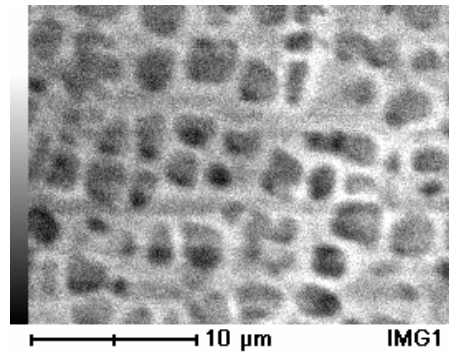
Fig. 5b SEM image at the vicinity of cooling whole (region B)

- 2 Diffused spot was observed at the vicinity of cooling hole where 5mm distant from the hottest point. a/c was 8.3. Microstructure shows array of cubic γ' and moderate grain growth.

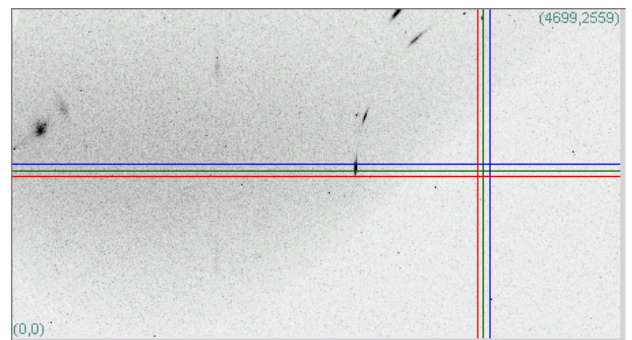
Figure 6a demonstrates the 2D diffraction image from the hottest region of the current blade (Fig.3 A). More clear spots were observed at γ' (111) plane. Strong intensity are suggesting that larger size of γ' precipitate than those of Fig.5a. Furthermore,

Fig. 6a IPXRD image from the hottest area of blade

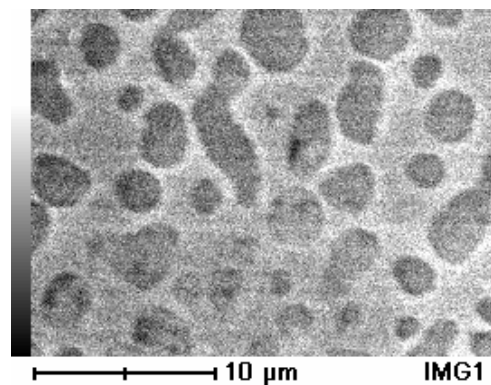
observed three spots in the γ' (111) plane are indicating that γ' precipitate is not aligned to one direction but is scattering. Figure 6b shows SEM image of the same hottest region of the blade. More sphere like γ' precipitates were observed because γ' precipitates were coalesced by creep deformation. If the turbine blade operates long period, γ' precipitates in this region would become more coarsened, therefore, durability of this material would be reduced drastically. These observations demonstrate the possibility in the detection technique of the microstructure changes by means of IPXRD.

Fig. 6b SEM image of the microstructure in the hottest area of blade

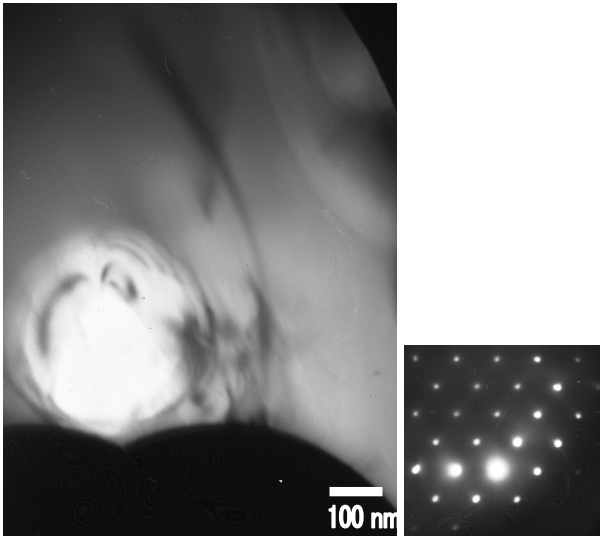
In order to examine the microstructure changes of the turbine blade in detail, TEM observations were carried out. Figure 10 shows the γ matrix and γ' precipitate of the root position of the blade, where it seems as-cast microstructure would be maintained. In Fig.10, (110) ordered diffraction spot appeared in the electron diffraction pattern. It is indicating that γ' precipitates have an ordered atomic arrangement.

Fig. 10 TEM observation from the root position of the blade. Bright field image (γ' precipitate) and diffraction Pattern

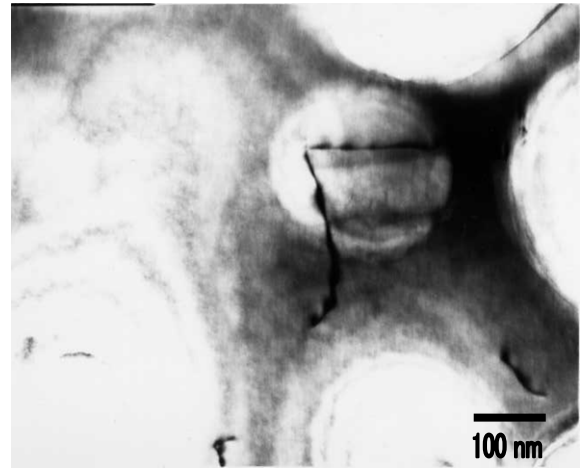
Fig. 12 TEM observation from the hottest portion of blade. Bright field image of dislocation at the γ/γ' interface and diffraction pattern.

Figure 12 shows the bright field image and the diffraction pattern from the thin foil specimen of relatively hot region of the blade. Dislocation is observed at γ/γ' interface. Lattice misfit angle between γ and γ' phases is one of the most important parameter to determine the high temperature strength of superalloy. γ/γ' interface become a strong obstacle to dislocation movements. Anchored dislocation was frequently observed in this used turbine blade.

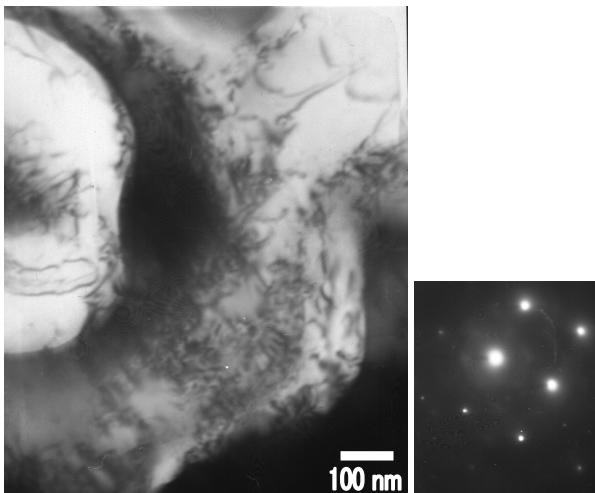
Figure 11 shows the TEM image of γ matrix and sphere γ' precipitate. In the γ matrix, dislocation network was observed. This observation was found out the macroscopic creep deformation was caused by the dislocation generations and propagations at high temperatures during the gas turbine operation. High dislocation density in γ phase could strongly contribute to the microstructure changes by enhancing the atomic diffusion and vacancy generation ⁽¹²⁾. Detail analysis would be necessarily to clarify the microstructure changes in Ni base superalloy in conjunction with the rafting mechanism .

Fig. 11 TEM observation from the hottest position of the blade. Bright field image of dislocation network in γ phase and diffraction pattern.
