## 疲労試験を行ったTiAl-Nb金属間化合物のTEM観察 TEM Observations of Fatigued TiAl-Nb Intermetallic Compounds

○ Daniel Albert Orozco Yanez<sup>1</sup> (M2) and Keizo Hashimoto<sup>2,3</sup>

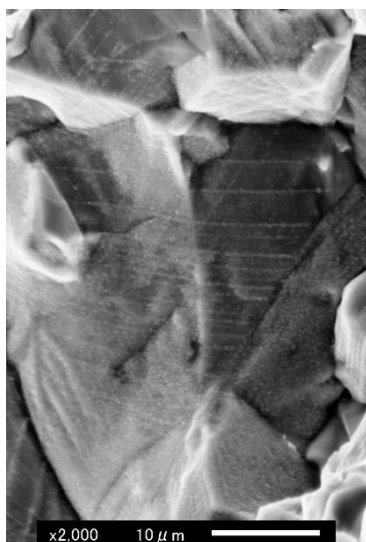
At the moment of the analysis of specimen composed by TiAl-Nb at 650°C, it can be observed serration spacing is 2.5 μm on the fatigue fractured surface frequently (Fig.1). These observations are similar to fatigued fracture of conventional metal. In Fig.2, deformation twins were observed with 100 nm spacing. Twin deformation frequently operated during fatigue test. Figure 3 show the high dislocation density region with dislocation tangling near the low dislocation density region. These observed dislocation structures would be corresponding to the ladder structure of the conventional fatigued metal specimen.

Fig.1 Serration appeared on intergranular fracture surface

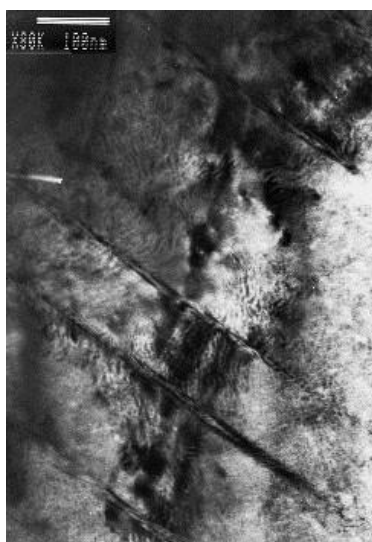
Fig.2 Deformation twins operated at the vicinity of fracture surface

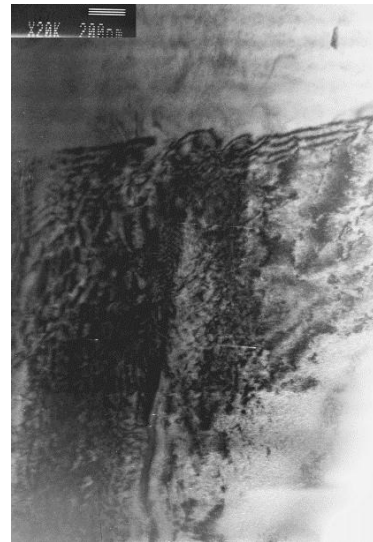
Fig.3 High and low dislocation density regions in fatigued specimen
