Observation of biofouling by using test plates in Hirado Strait of Nagasaki, Japan

Abstract—Relating the cost of the tidal power generation, the bio-fouling effects on the tidal turbine may be important since it is relevant to the maintenance cost of the power device for a long time. Field measurement results of the bio-fouling effects on test plates at the Hirado-Seto Strait in Nagasaki Prefecture are reported. Test plates include 5 plates without paint and a plate with silicon paint and 4 plates with anti-fouling offshore structure and ship bottom paints. The experimental frame with the test plates are hung from the breakwater into the sea and are raised from the sea every month regularly to observe the bio-fouling by taking pictures and measuring the weight of the plates. It is clarified that the dominant species around the adjacent sea are the triangle- and red-barnacles which do not newly attach if seawater temperature becomes below 20 degree in centigrade, but it continues to grow even in winter if it once attached. Observation is still running since September 2013 and the results for more than 3 years are presented.

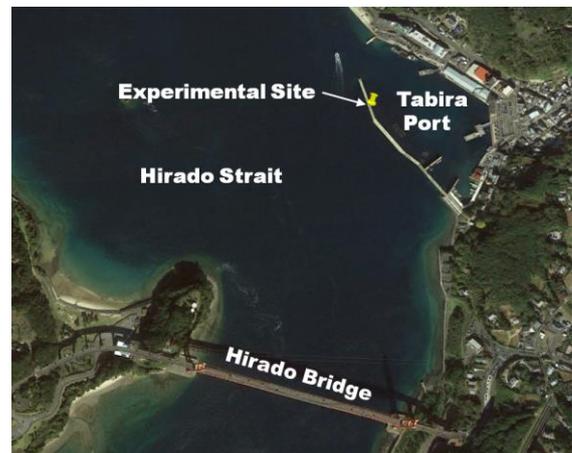
Fig.2 Test site at the breakwater in Tabira Port

Fig. 1 shows the map of Hirado Strait and the location of the Tabira Port. The experimental site is at a point of the breakwater of Tabira Port in Fig. 2, where the tidal current is strong since it is near from the narrowest part of Hirado Strait. This site is about 80 km in the Northeast from the Naru Strait of Goto Islands where the tidal current power project by the Ministry of Environment is currently underway and the ocean environment of both sites may be quite similar.

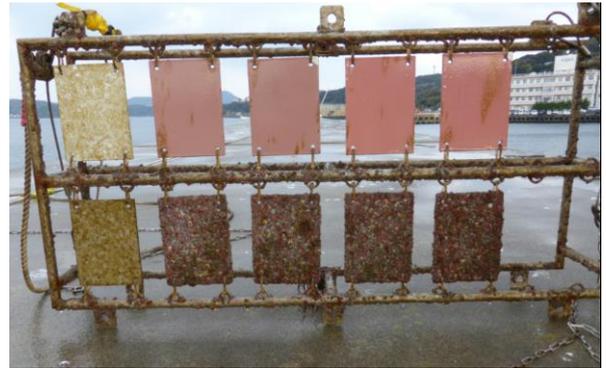
Fig.5 Picture of the biofouling test plates after 3 months on 11 December 2013

The first immersion of the device was made on 13th September 2013. Since then, regular observation has been conducted once a month around 11th day of the month. Fig.5 shows a picture taken just after the recovery on 11 December 2013, 3 months after the starts. In the regular observation, taking pictures of both sides of the plate, measuring the weight of each plate, and the data download from the water temperature meter are conducted within 2 hours. The reason why this observation is stably possible in the channel with strong tidal current is that the venue is on the breakwater so that we can access on foot without effect of weather condition. Furthermore, there is a locked fence in the middle of the breakwater so that other people are restricted to access there. We thank greatly the Nagasaki Prefectural Civil Engineering Office for their permission of us to use the breakwater for this observation.

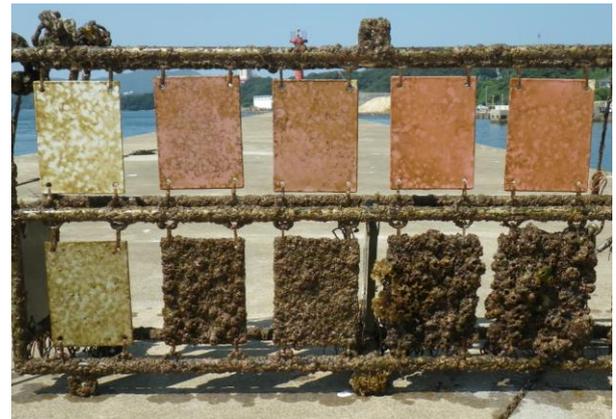
Fig.8 A picture of the bio-fouling test device after one year on 11 September 2014

Fig. 8 shows the picture of the experimental device just after raised from water on 11th September 2014 after one year deployment. From this picture, we understand the big difference between painted or no painted plates. There was no barnacle attached on the painted plates although the biofilm or algae was seen on the surface. On the other hand, we could see a large amount of sessile organisms on the plates without paint in the lower row. We found 13 species of plants including green algae, brown algae and red algae. For marine creature, we found 29 species including the arthropod, soft-bodied creature, bivalves and echinoderms but more than 99% of the weight of them was occupied by triangle-barnacles (*balanus trigonus*) and red-barnacles (*Megabalanus rosa*).

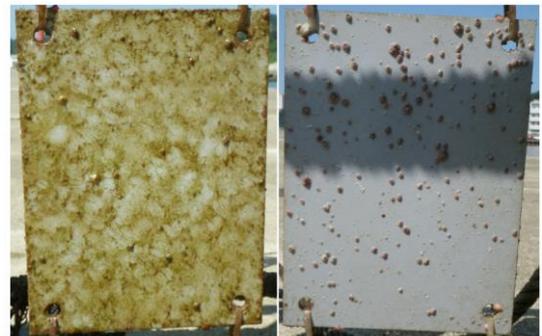
Fig.9 Face and back of one-month plate on 11 September 2014

Fig.9 shows the picture of the face and back surfaces of one-month plate on 11 September 2014. We can observe the face side was covered by the green algae and some baby barnacles were attached, while the back side was no color but baby barnacles more than face side were found. This fact that the number of barnacles on the back side of one month plate was more than the face side was applied normally every month.

Fig. 10 shows the picture of 3 months plate. Face side was fully covered by brown colored barnacles. Back side was also covered by barnacles but total number was less than the face side. Difference in colors between face and back sides in Figs 9 and 10 may be attributed to the algae on the surface, which relates the effects of sunlight.

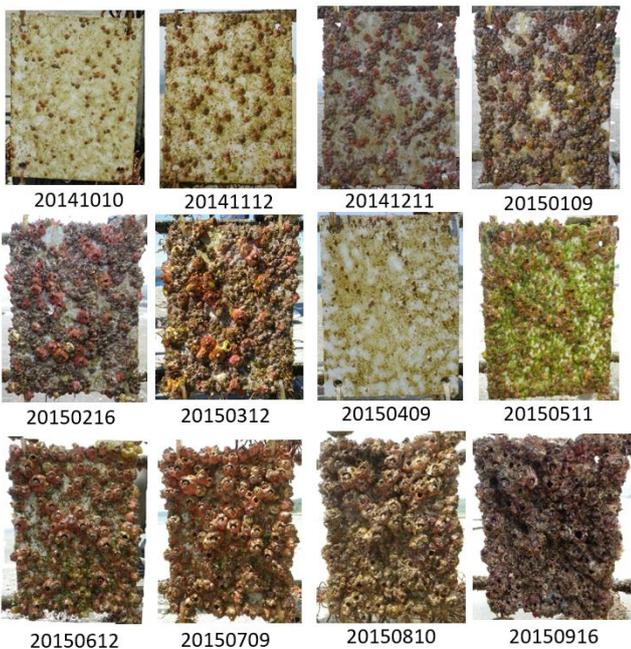
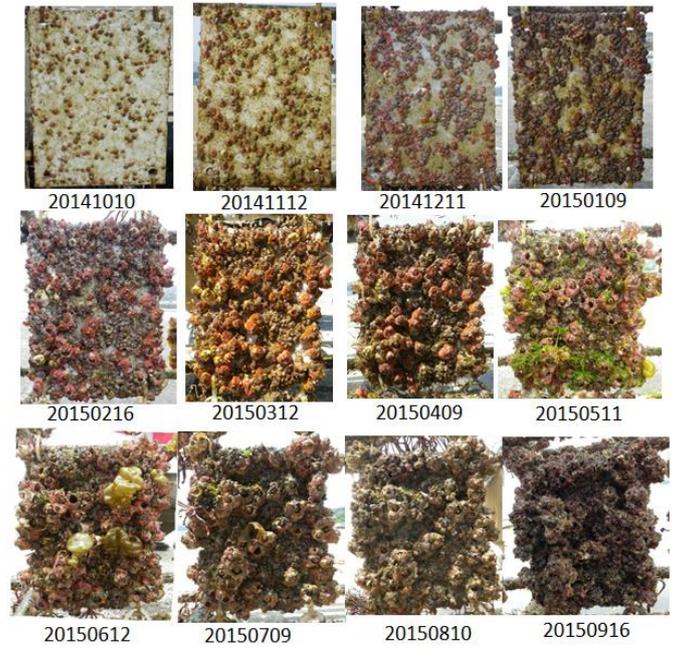
Fig.13 and Fig.14 show the pictures of 6 month plate and 12 month plate. They were quite same condition until March 2015, so that the growth of both plates was similar. The weight of 12 month plate showed the saturation after 8 month because there was no more space for barnacles to attach and grow on the plate.
