Study on riverbed variation management by groin at a river confluence associated with the barrage water

ABSTRACT: The Kakogawa River, which has a catchment area of 1730 km² and a length of 96.0 km, flows through Hyogo Prefecture in Japan. The influence of runoff due to barrage water and the Mino River tributary, combined with a meander in the river upstream from the large barrage on the Kakogawa River (Kakogawa Barrage), has promoted the development of a sandbar on the riverbank opposite the confluence. This sandbar, which has enlarged and become fixed, currently deflects the passage of water back to the left bank and has decreased the river's usable water-surface area. To wash away the sandbar, a groin was installed in 2015. The purpose of this study was to survey the river's topography in the vicinity of the Mino River confluence and identify the factors responsible for sandbar development using model experiments and numerical analysis. In addition, the function of the groin and the effects of changing its characteristics were verified.

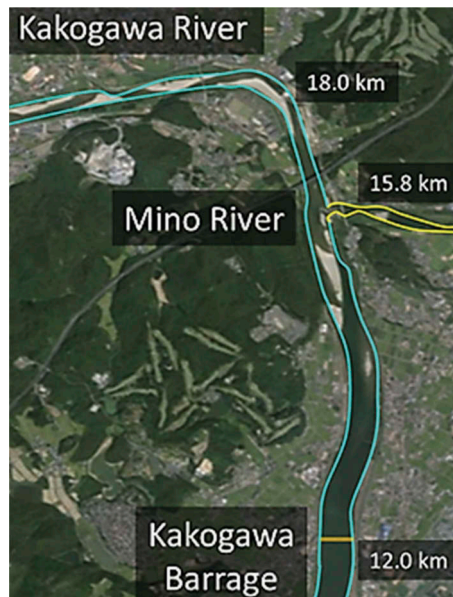
Figure 1. Aerial photograph of the site.

The Kakogawa River, which has a catchment area of 1730 km² and a length of 96.0 km, flows through Hyogo Prefecture in Japan. The Mino River, which has a catchment area of 304 km² and a length of 39.0 km, flows at a right angle to the Kakogawa River. The confluence of the two rivers is 15.8 km from the estuary (**Figure 1**). Around the confluence, the width of the main channel is nearly 200 m and its slope is about 1/850. The width of the tributary channel is nearly 120 m and its slope is about 1/500; however, the influence of the tributary channel's slope can be ignored because a falling work with a height of 2 m was installed upstream of the Mino River, before the confluence. In 1989, the Kakogawa Barrage was constructed 12.0 km from the estuary to improve the reliability of flood control and to respond to the rapidly increasing demand for water. In normal times, the backwater caused by the barrage affects the upstream of the confluence.

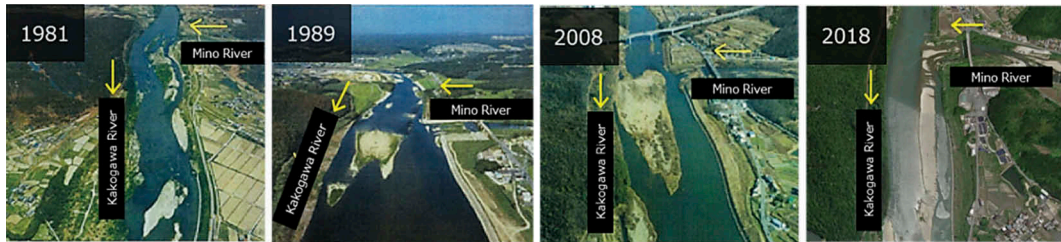
Figure 2. Morphological changes in the confluence.

Figure 2 shows the morphological changes in the confluence before and after construction of the barrage and groin. At the same time as the construction of the barrage, upstream river modifications were made, which promoted the development of a sandbar opposite the confluence. In 1981, before the barrage was constructed, the main flow area was on the right side of the river. However, in 1990, after the barrage was constructed, the main flow area had moved to the left because of the sandbar. Furthermore, the upstream river channel of the confluence has a right-angled meander 18 km from the estuary, and a narrow segment was formed due to protruding bedrock on the left bank of the low-water channel at 16.7 km from the estuary. It is considered that the development of the sandbar in the confluence has been influenced by the meander upstream of the Kakogawa River, the backwater from the Kakogawa Barrage, and the Mino River tributary.

In 2015, a groin was installed to control the development of the sandbar just upstream of the confluence. This groin was made by block stacking, and it is 50 m long, 15 m wide, and 6 m high. It aims to manage the sandbar by deflecting the main flow toward the right bank during flooding, but the function of the groin has not been adequately verified. Now, the sandbar has been flushed by the groin, but a new sandbar is developing behind the groin, and a small deposition can be observed in front of the groin.

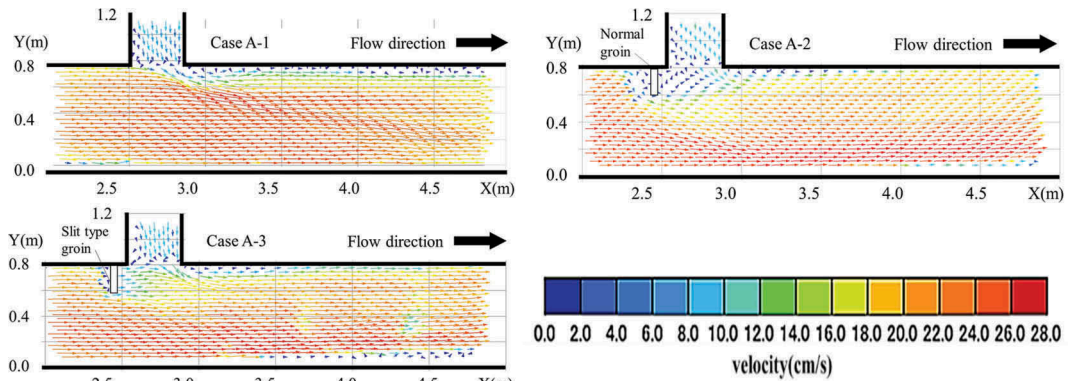
Figure 5 shows the results regarding the water surface velocity in flood conditions. In Case A-1, the maximum flow velocity was observed downstream from the confluence, and a dead-water zone was observed near the left bank, behind the confluence. However, in Case A-2, the maximum flow velocity area moved to the right bank due to installation of the groin. The dead-water zone after the confluence decreased, but the area around the groin also became a dead-water zone because the groin greatly changed the flow. In Case A-3, a slit-type groin was installed. In the results, the maximum flow velocity was observed in the same area as in Case A-2. Because water can flow through the slit-type groin, the vectors of this flow were

Figure 5. Water surface velocity (Cases A-1 & A-2&A-3).

observed behind the groin, and there was no dead-water zone behind it. Based on these results, each groin can change the main flow area to the right bank. The occurrence of the dead-water zone around the groin depends on the shape of the groin, which determines whether water can flow through the groin or not.

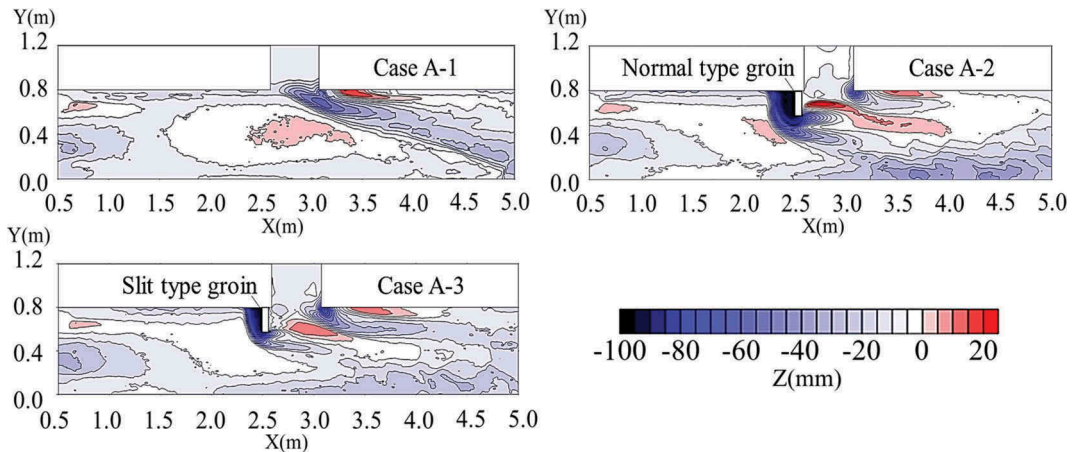
Figure 6 shows the results regarding riverbed variation in flood conditions. In Case A-1, riverbed degradation occurred along the tributary flow, and deposition occurred in the middle of the channel near the confluence. It seems that this sandbar reproduces the actual topography of the site, but the position actually differs from that at the site. We think this difference is caused because we did not consider the sand feeding by the tributary flow. Downstream from the confluence, the deposition occurred near the left bank. The results for Case A-2 showed the effects of riverbed variation with the installation of a normal-type groin. In Case A-2, riverbed degradation occurred near the right bank after the confluence because the groin deflected the flow toward the right bank before the confluence. When this flow was sharply deflected by the groin, a secondary wave occurred in front of the groin, the flow from which caused deep scouring in front of the groin. In contrast, deposition developed behind the groin, preventing the flow of the tributary. Unlike in Case A-1, no deposition near the confluence was observed in Case A-2. Accordingly, the groin can flush the sandbar but also promotes the development of a new sandbar behind the groin.

The results of Case A-3 show the riverbed variation with the installation of a slit-type groin. Because a slit-type groin is a transmission-type one, the deflection effect was diminished and the scouring area in front of the groin decreased in comparison with the results of Case A-2. The deposition area and its height also decreased. Riverbed degradation was observed near the right bank, so it is considered that the slit-type groin has a flushing effect like that of the normal-type groin and that deposition behind the groin can be reduced by using a slit-type groin.

Figure 6. Experimental results for riverbed variation (Cases A-1, A-2, & A-3).

- (2) The normal-type groin can flush the deposition that produces the sandbar. However, a deposition develops behind the groin, and deep scouring occurs in front of it. Measures against these problems are needed. A slit-type groin can reduce the riverbed variation around the groin and retain the flushing effect.

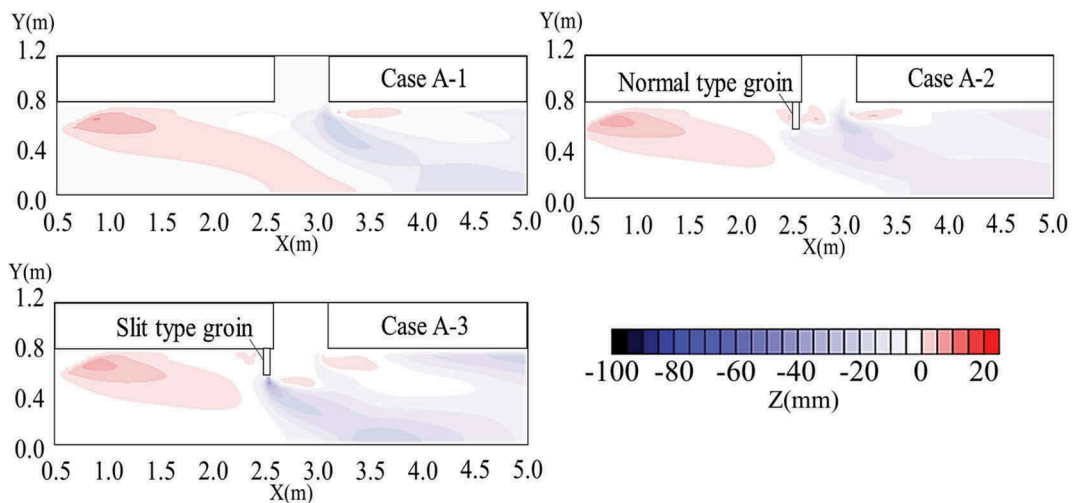
Figure 8 shows the results of the numerical calculations using the iRIC Nays2DH. In these results, the effect of using the board as the upstream boundary condition were stronger than in the experimental results, resulting in deposition developing from the left bank of the upstream part to the middle of the channel. In the absence of a groin, the tendency regarding riverbed variation was the same as in the experiment. Installation of the groin reproduced the

Figure 8. 2-D analysis results for riverbed variation (Cases A-1, A-2, & A-3).

scouring at the tip of the groin and the riverbed degradation near the right bank, after the confluence. However, the deep scouring in front of the groin was not observed. It seems that deep scouring was caused 3-D analysis

- (5) Numerical calculations using the iRIC software can reproduce the experimental results under the condition in which no groin is installed. In the case in which a groin is installed, the numerical calculation cannot reproduce the river bed variation around the groin.
