Study on Effect of Confinement of Reinforced Concrete Retrofitted Joints Using Horizontal Haunches

Takumi UENO¹, Shuichi UEHARA², Tatsuaki AOTA³

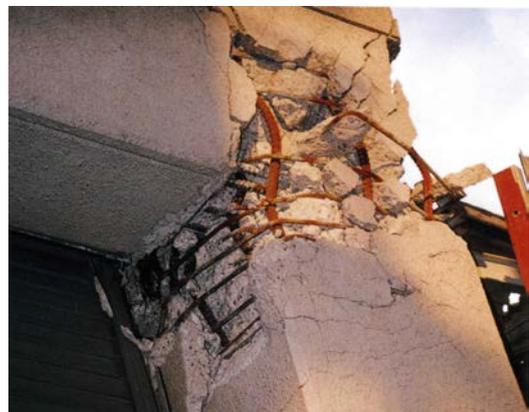
Fig.1 Failure of beam-column joint

In the Hyogo-ken Nanbu Earthquake of 1995, the beam-column joints of many RC buildings designed based on the new earthquake resistant standard suffered great damage. Fig.1 shows an example of joint failure in the earthquake. Some damage of the joints due to the Tohoku Region Pacific Offshore Earthquake that occurred in 2011 was also observed. The necessity of earthquake-resistant design of joints was clarified by enforcement order of revised Building Standard Law in 2007, and the performance of joints in current law is required for extension and remodeling of existing RC buildings over a certain scale. However, there is no practical and effective method.

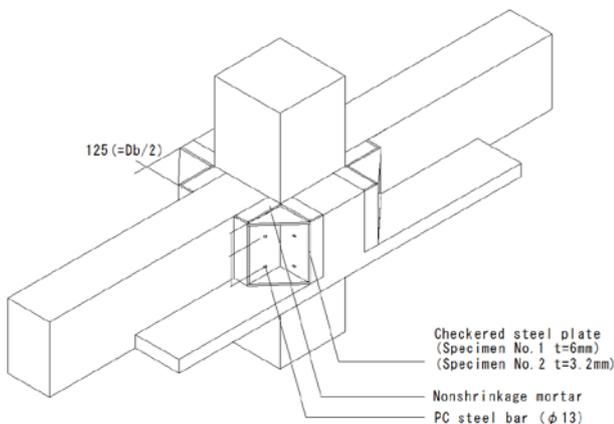
Fig.2 shows the retrofit method of the specimen. The specimen has horizontal haunches by the beam and the cross beam. This is a method of thickening the beam width to the column width by mortar, and pressing the steel plate against the side surfaces and crimping them with $\phi 13$ PC steel rod. This reinforcement aims to increase the volume of the joint and to move the beam plastic hinge generation position from the beam end to the retrofitted toe end.

Fig.2 Retrofit method of the specimen

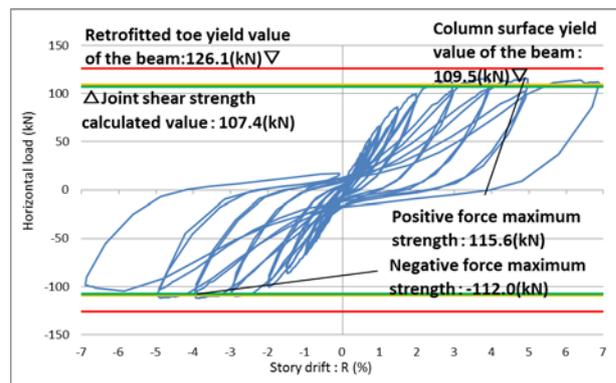
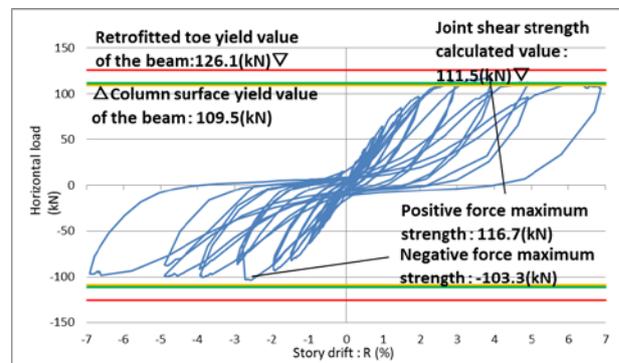
Fig.3 shows the relationship between the horizontal load N and the story drift angle R . In the specimen No.1, the maximum strength was obtained at $R=5.0\%$ and the beams were failed by bending at $R=7.0\%$. In specimen No.2, at $R=4.0\%$, the maximum strength was obtained, and at $R=7.0\%$, crushing of the beam ends was less than that of the specimen No.1, so it was considered that joint failure was progressed.

Fig.3 Horizontal load and the story drift

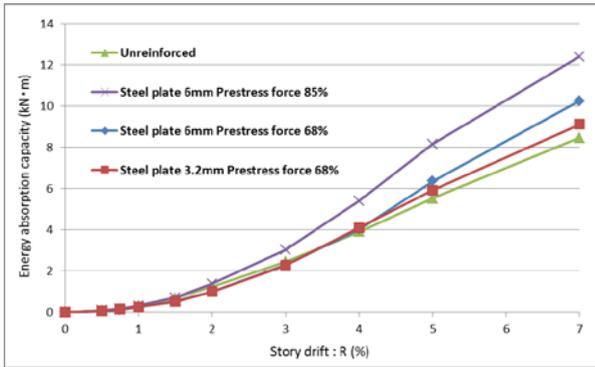
Fig.4 shows difference of energy absorption capacity of each specimen. In the specimen No. 1, it can be said that there is an influence from the steel thickness because the energy absorbing ability is larger than that of specimen No.2.

Fig.4 The energy absorption capacity of each specimen

- (1) When the restraining force was weakened due to less prestressing force or reduction in steel sheet thickness, the energy absorption capacity decreases.
- (2) When the restraining force was weakened due to less prestressing force or reduction in steel sheet thickness, the hinge generation position moves from retrofit haunch ends to the vicinity of the joint, and the joint is prone damaged.

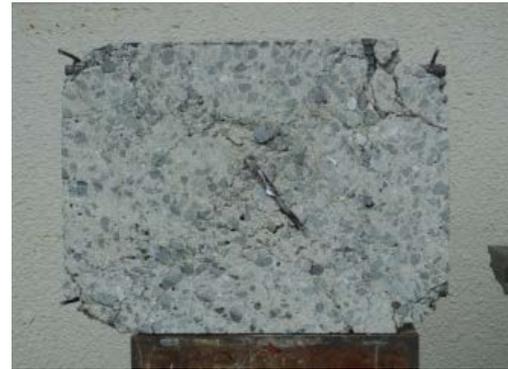
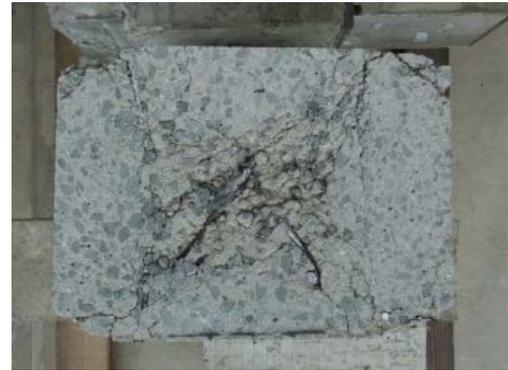
Fig.5 shows specimens after experiment. Fig.6 shows the inside section of the joint panel after experiment. Comparing the photo of the joint panel of the specimen No.1 of Fig.6-(a) with the one of specimen No.2 of Fig.6-(b), it can be seen that damage is more pronounced in Fig.6-(b).

Fig.6 Inside section of the joint panel

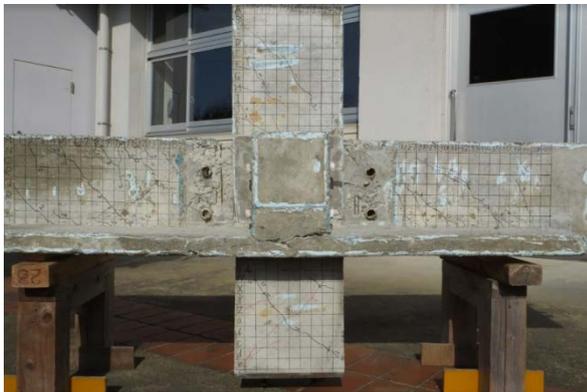
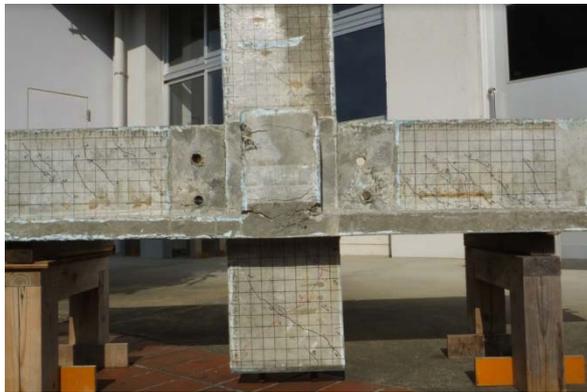
Fig.5 Specimens after experiment
