Damage Assessment and Guidelines for Restoration Methods of Ancient Brick Structures at Sambor Prei Kuk, Cambodia

Ichita Shimoda, Sokuntheary So & Vitharong Chan

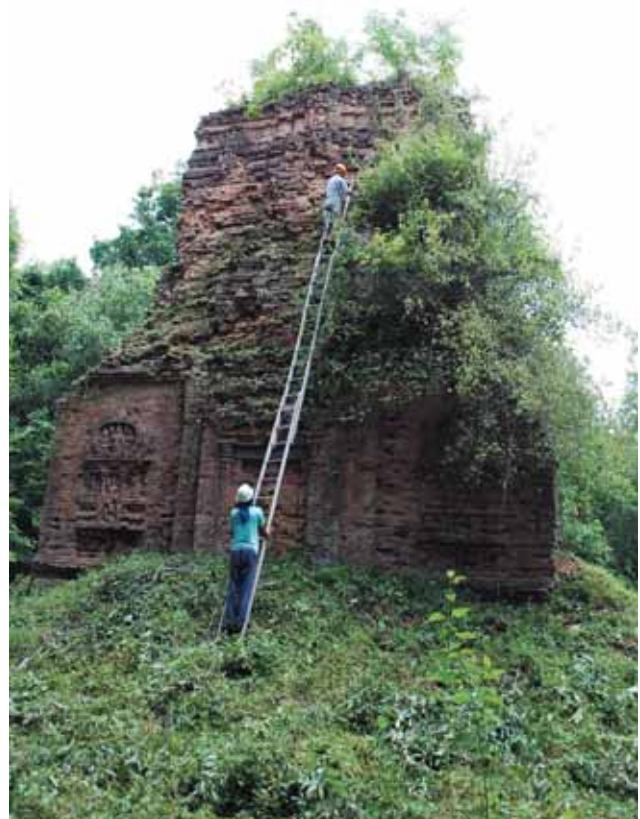
Figure 3. Removing vegetation on the brick structure as the periodical maintenance activities at N15 shrine.

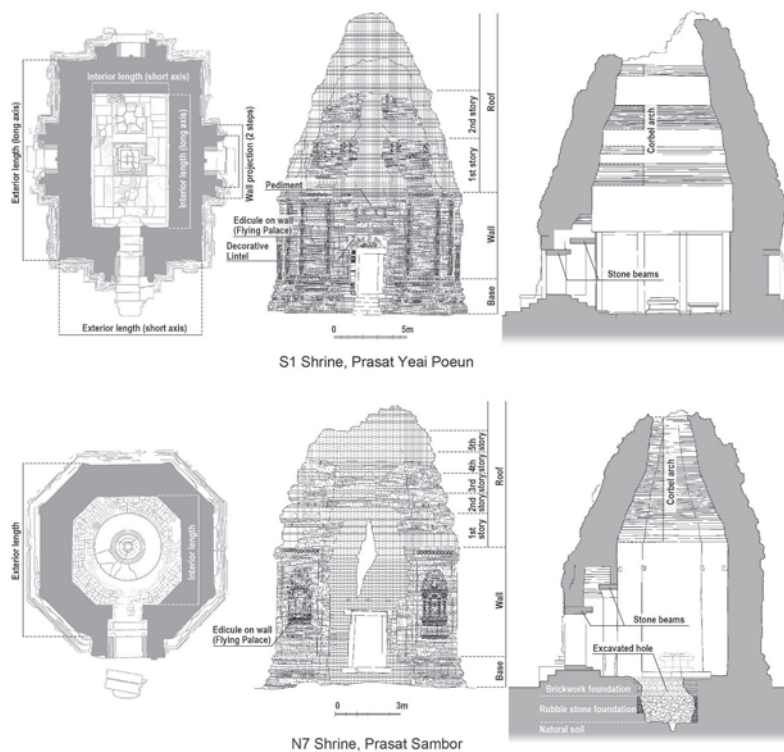
Figure 4. Plan, elevation, and section drawings of the representative brick structures in Sambor Prei Kuk (above) S1 shrine (high tier roof type structure) and (below) N7 shrine (low tier roof type structure).

walls. As the square and rectangle shrines with stepped projection wall such as S1 shrine for increasing the thickness of the supporting wall as a buttress function are in better preserved condition than the shrines of flatten walls as N7 shrine (Figure 4). The projected wall plan at the middle of each side contributes to the structural stability.

As described above, the style of roof is classified into high tier type and low tier type (Figure 4). The thrust by the corbel arch of the low tier type might be larger than the structures of high tier type because the roof of lower tier type is a gentler slope. Because all octagonal shrines are low tier roof type and the thickness of the wall is relatively thin, the wall of octagonal shrines has suffered the damage of wider cracks by large inclination.

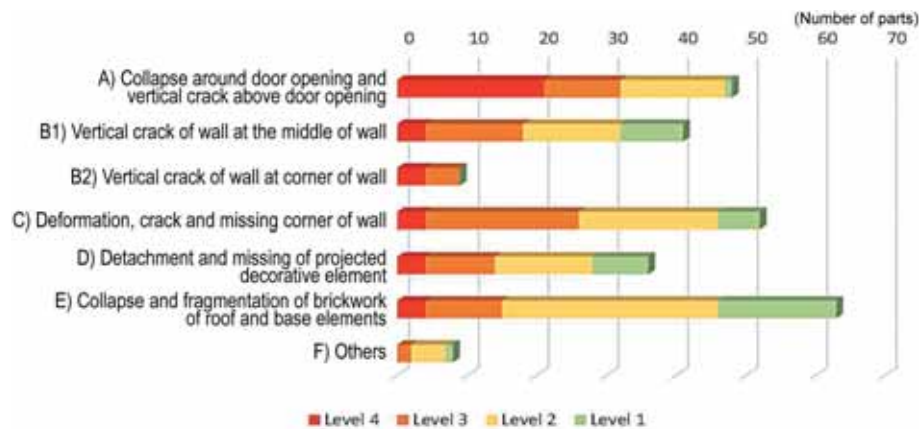
As a result of this risk map a total of 257 hazardous parts were identified (Supplemental material 2). The number of Level 4 is 41 parts, Level 3 is 75 parts, Level 2 is 99 parts, and Level 1 is 42 parts (Figure 12). Many high levels of the risk element were observed around the door opening. Deterioration at the roof and base was large in number, but the number of higher risks of further collapse was relatively smaller than the other deteriorated elements. It was revealed that the

Figure 12. Number of deteriorated elements and risk levels, classified by deteriorated type.
