Observations of Microstructure Changes in Used Turbine Blade by IP-XRD SEM and TEM

Keizo Hashimoto, Hiroaki Fujita and Hiroshi Hamamoto

Department of Aerospace Engineering Teikyo University
1-1 Toyosatodai Utsunomiya 320-8551 JAPAN

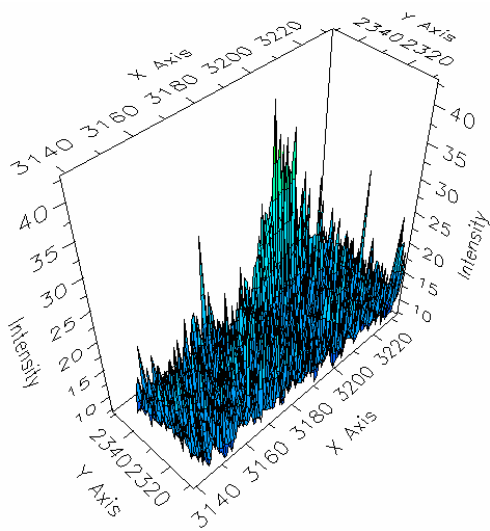
Fig.7 3D diffraction profile of Fig.5a ring pattern

In order to quantify the morphology of the turbine blade, diffraction from γ' (111) plane was selected for the further analysis. Ring pattern (Fig.4a) , diffused spot (Fig.5a) and intense spot (Fig.6a) are implying the information of crystal morphology in the reciprocal lattice space. If a crystal is consisting of the perfect single crystal with isotropic atomic arrangement, sphere shape diffraction spots would appear in the reciprocal lattice space. Therefore, the cross section of the diffraction spot should be a circle when Laue's diffraction condition is consists ⁽¹¹⁾. If an ellipse is observed in the reciprocal lattice space, it is demonstrating that crystal contains a kind of the anisotropy, such as existing of polygonization , imperfection, elongated grain and so on. Figure 7 shows the three dimensional (3D)profile of (111) ring pattern (see Fig.5a). Figure 8 shows the 3D profile of (111) spot at the vicinity of cooling hole (see Fig.6a). Figure 9 shows the 3D profile of (111) spot from the hottest region of the blade (see Fig.7a).

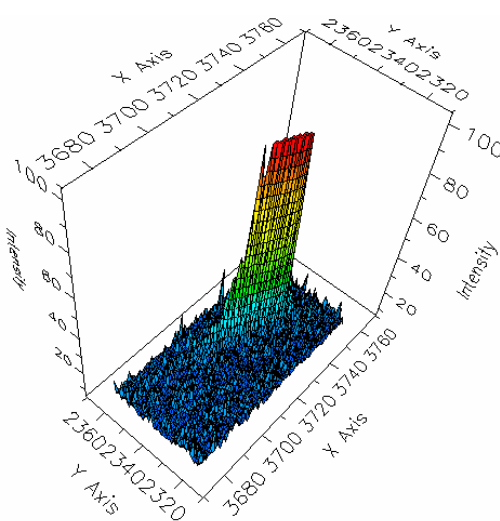
Fig. 9 3D diffraction profile of Fig.7a (111) intense spot

According to Table 3, an agreement between the aspect ratio **a/c** and tendency of the microstructure changes from SEM observations are evident. Consequently, the aspect ratios of diffraction from γ' precipitates would become the first estimation of the microstructure changes for the nondestructive evaluation.
